NCST Investigation of the Champlain Towers South Collapse

3D Visualization of Evidence

David G. Goodwin Jr., Ph.D.

Georgette Hlepas, Ph.D., PE Project Leader, Remote Sensing & Visualization Project

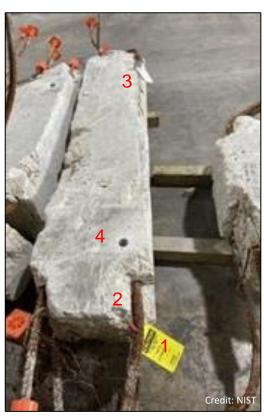
Physical Evidence Tagging

Physical evidence specimens were tagged with (1) paper tags and (2) wire lock tags

Physical evidence specimens were next tagged with (3) detailed paper tags and (4) radio-frequency induction (RFID) tags

NIST physical evidence database entries for specimens are securely accessed by reading RFID tags with a NIST mobile device.
